PERMANENTLY STABILIZING A CREEPING SOIL SLOPE BY A FLEXIBLE SLOPE STABILIZATION SYSTEM

T. Hangartner¹, D. Kurniawan² and C. Balg³

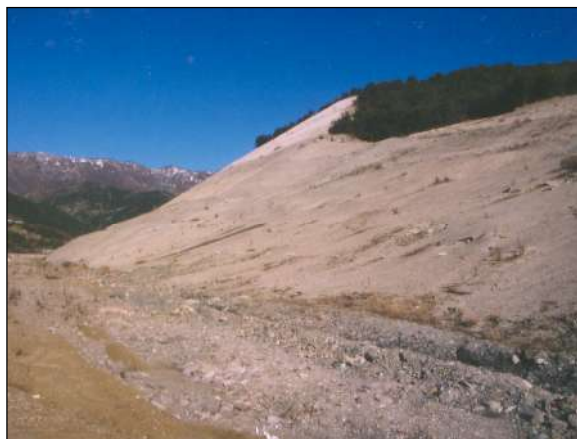
Figure 3. Shotcrete facing at location D

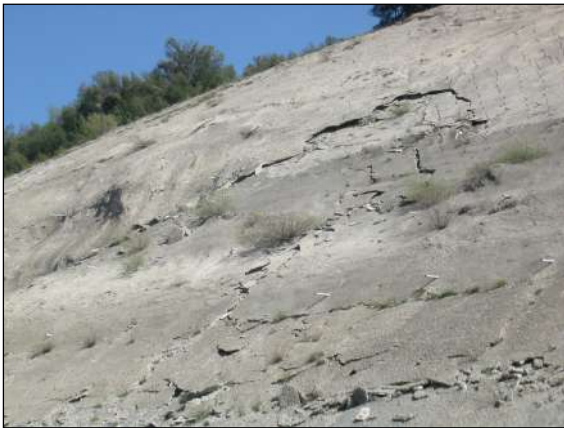
Figure 6. Superficial cracked shotcrete

In general, the applied shotcrete is of poor quality. Evidently, the fraction of cement added was partially too low visible due to the darker colour of the shotcrete. In those areas, up to 20 – 25 mm of the top layer the shotcrete facing is strongly weathered and mellow with the result of cracks within the shotcrete facing. The areas lighter emerging are of better quality less weathered and in better condition. Next to the bad quality of the shotcrete facing, the main problem was the erosion of the subsoil just behind the shotcrete due to insufficient or not adequate drainage measures, respectively. Locally, there was no contact anymore between the subsoil surface and the shotcrete facing.

In a first step, the shotcrete facing was completely removed. Instead of a cover layer impermeable with a stiff behaviour, a flexible slope stabilization system was installed consisting of the high-tensile steel wire mesh TECCO® in combination with special system spike plates adapted to the high-performance steel wire mesh in its size and bending resistance based on numerous puncturing and bending tests. GEWI D = 28 mm with a length of 8 m and in a pattern of 3.0 m x 3.0 m are used for the nailing of the slope whereas the mesh is connected to each nail head by special spike plates. The forces are then transferred from the mesh over the plate into the anchors.

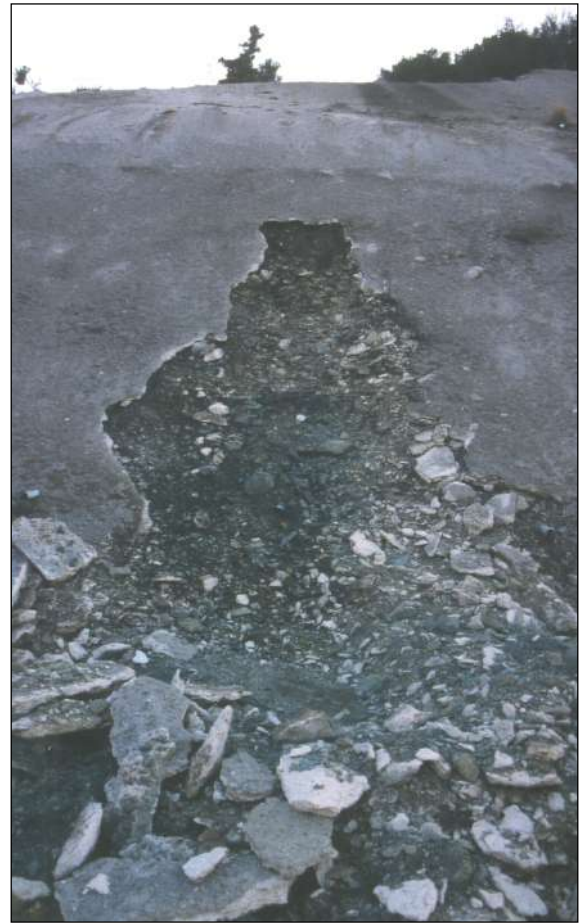
Figure 7. Thin shotcrete cover of Flysch material

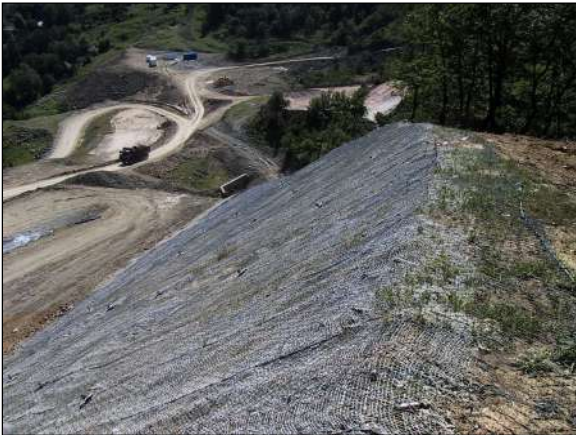
Figure 8. After installation

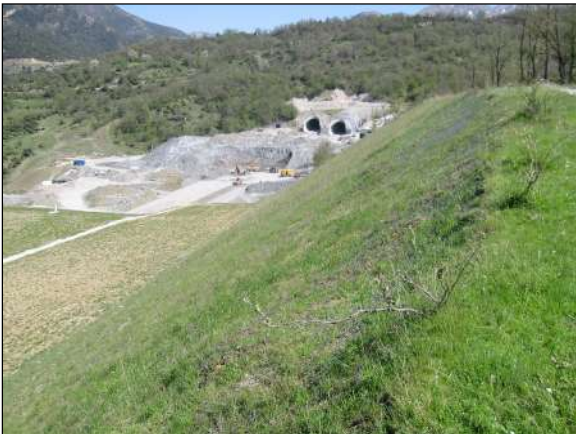
Figure 9. After one year

Two years from installation with dry and hot summers and cold, wet winter weather the slope is establishing a continuous vegetation cover itself, even so it is built into flysch mainly consisting of sand and siltstones. After an initial grass greening the local vegetation is slowly creeping back onto the stabilised cut slope with bushes and shrubs. No additional irrigation or revegetation has been carried out during this period. The visual impact of the slope as described is much more appealing compared to the big grey patches formed by the older shotcrete slopes.

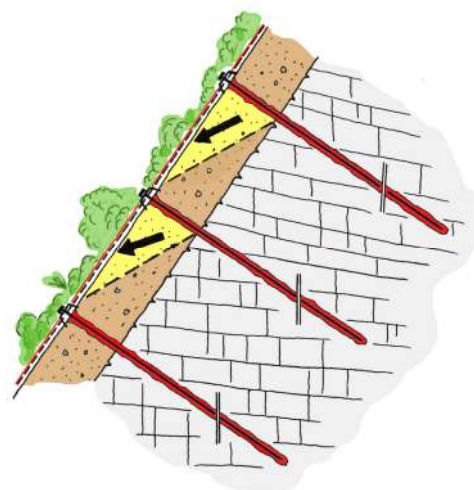
Figure 11. Local instabilities between single nails

The nailing was adapted to the static requirements based on the investigation of the overall stability considering sliding mechanisms with deeper-seated sliding surfaces. In addition to this, one needed to check if the flexible slope stabilization system consisting of the mesh cover and corresponding system spike plates in combination with the existing nailing can withstand all stresses as a result of superficial instabilities. Based on the RUVOLUM® dimensioning concept world-wide published and accepted, local instabilities between the single nails as well as superficial slope-parallel instabilities as shown in figure 11 and 12 had to be investigated. Thereby, all proofs of bearing safety could be fulfilled.

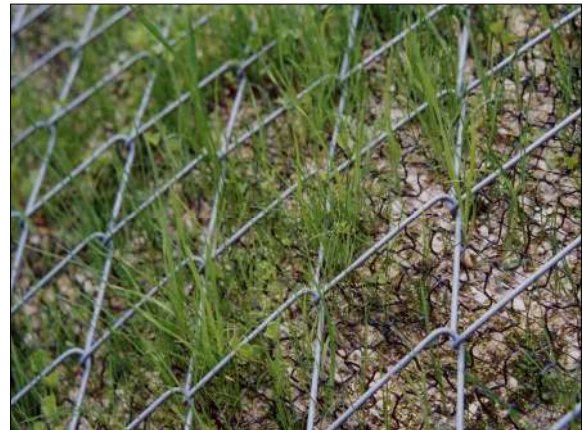
Figure 13. High-tensile steel wire mesh TECCO®

individual wire of at least 1,770 N/mm² of 3 mm diameter which has an aluminium-zinc coating (so-called GEOBRUGG SUPERCOATING®) for protection against corrosion. The diamond-shaped meshes measuring 83 mm · 143 mm are produced by single twisting. The TECCO® steel wire mesh provides a tensile strength of 150 kN/m. Thanks to its three-dimensional structure, the mesh clings to the soil in an ideal manner and, additionally, serves to optimally secure subsequent sprayed-on greening.

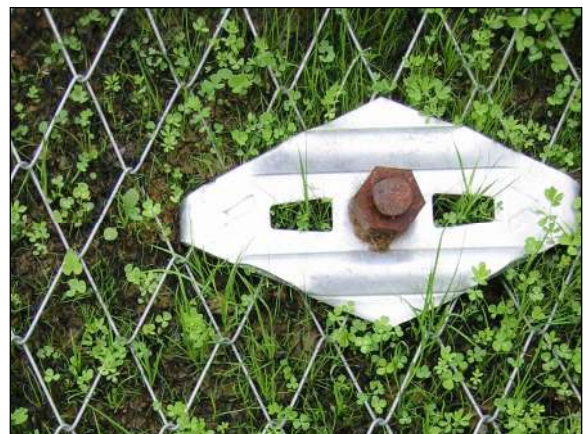
Figure 14. High-tensile steel wire mesh TECCO®
